A **61 year old male** employee was fatally injured when his **foot became lodged under the dash** of his truck as he put it in reverse before sitting fully on the seat subsequently falling and being dragged by the truck.

2 crushed by---Inspection #1373050 Civil Constructors LLC

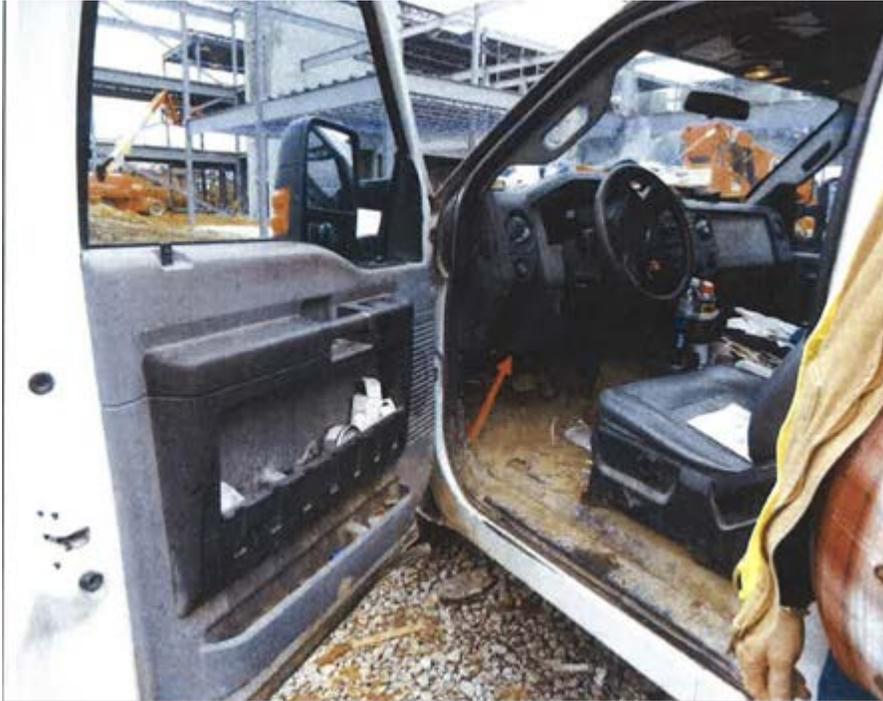
The CSHO obtained video surveillance of the accident from the building next to the job site. It was determined that the victim did not sit down in the seat of the truck. However, the victim's right foot was in the truck cab. At some point the victim was able to put the truck into gear with his left foot still on the ground before it started rolling backwards. As the truck was rolling backwards, the victim fell and was dragged on his stomach by the truck with his right foot caught under the dash.

This photo shows the victim's truck driver's side door open. The red arrow indicates where his foot was caught under the dash.

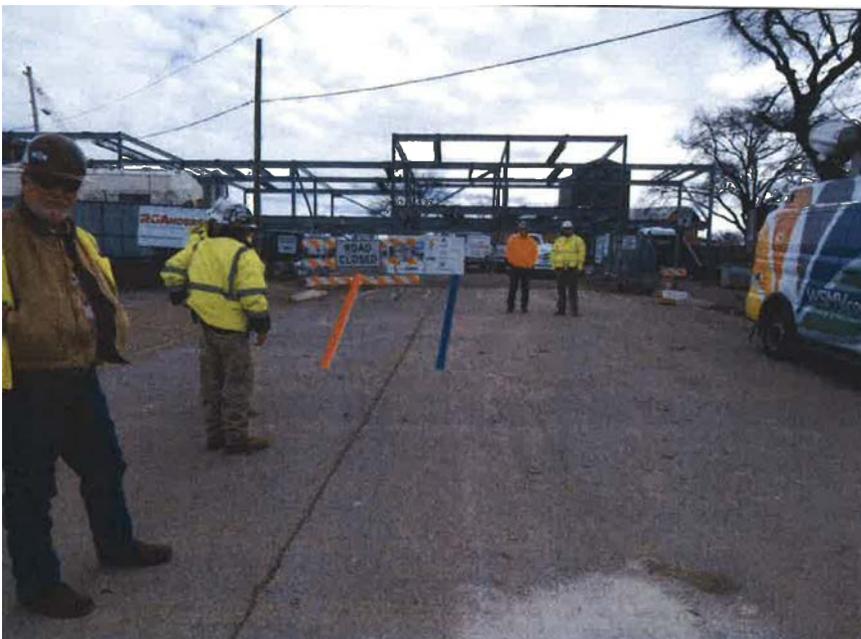
This photo shows where the two employees' trucks were parked. The red line indicates where the Utility Manager's truck was approximately located. The blue line indicates where the victim's truck was approximately located (before the accident). It also shows the gates that go into the construction site. In this picture, at the time of the incident, the laborer's truck was located where the WSMV van is shown.

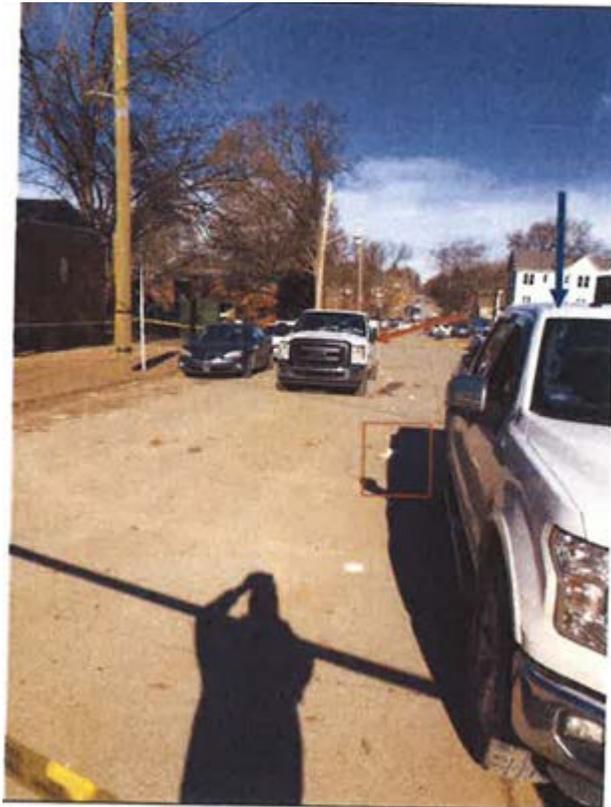
This photo was received by the General Contractor. This photo shows where the victim's truck ended up (red arrow). The red square indicates where the victim's left shoe fell off. The blue arrow indicates the Utility Manager's truck.
